**SEISMIC RELIABILITY STUDY OF THE
SEATTLE WATER DEPARTMENT'S
WATER SUPPLY SYSTEM**

Seattle Water Department
Dexter Horton Building
710-2nd Avenue
Seattle, Washington 98104

Cygn Energy Services
2121 N. California Blvd.
Walnut Creek, California 94596

February 6, 1990

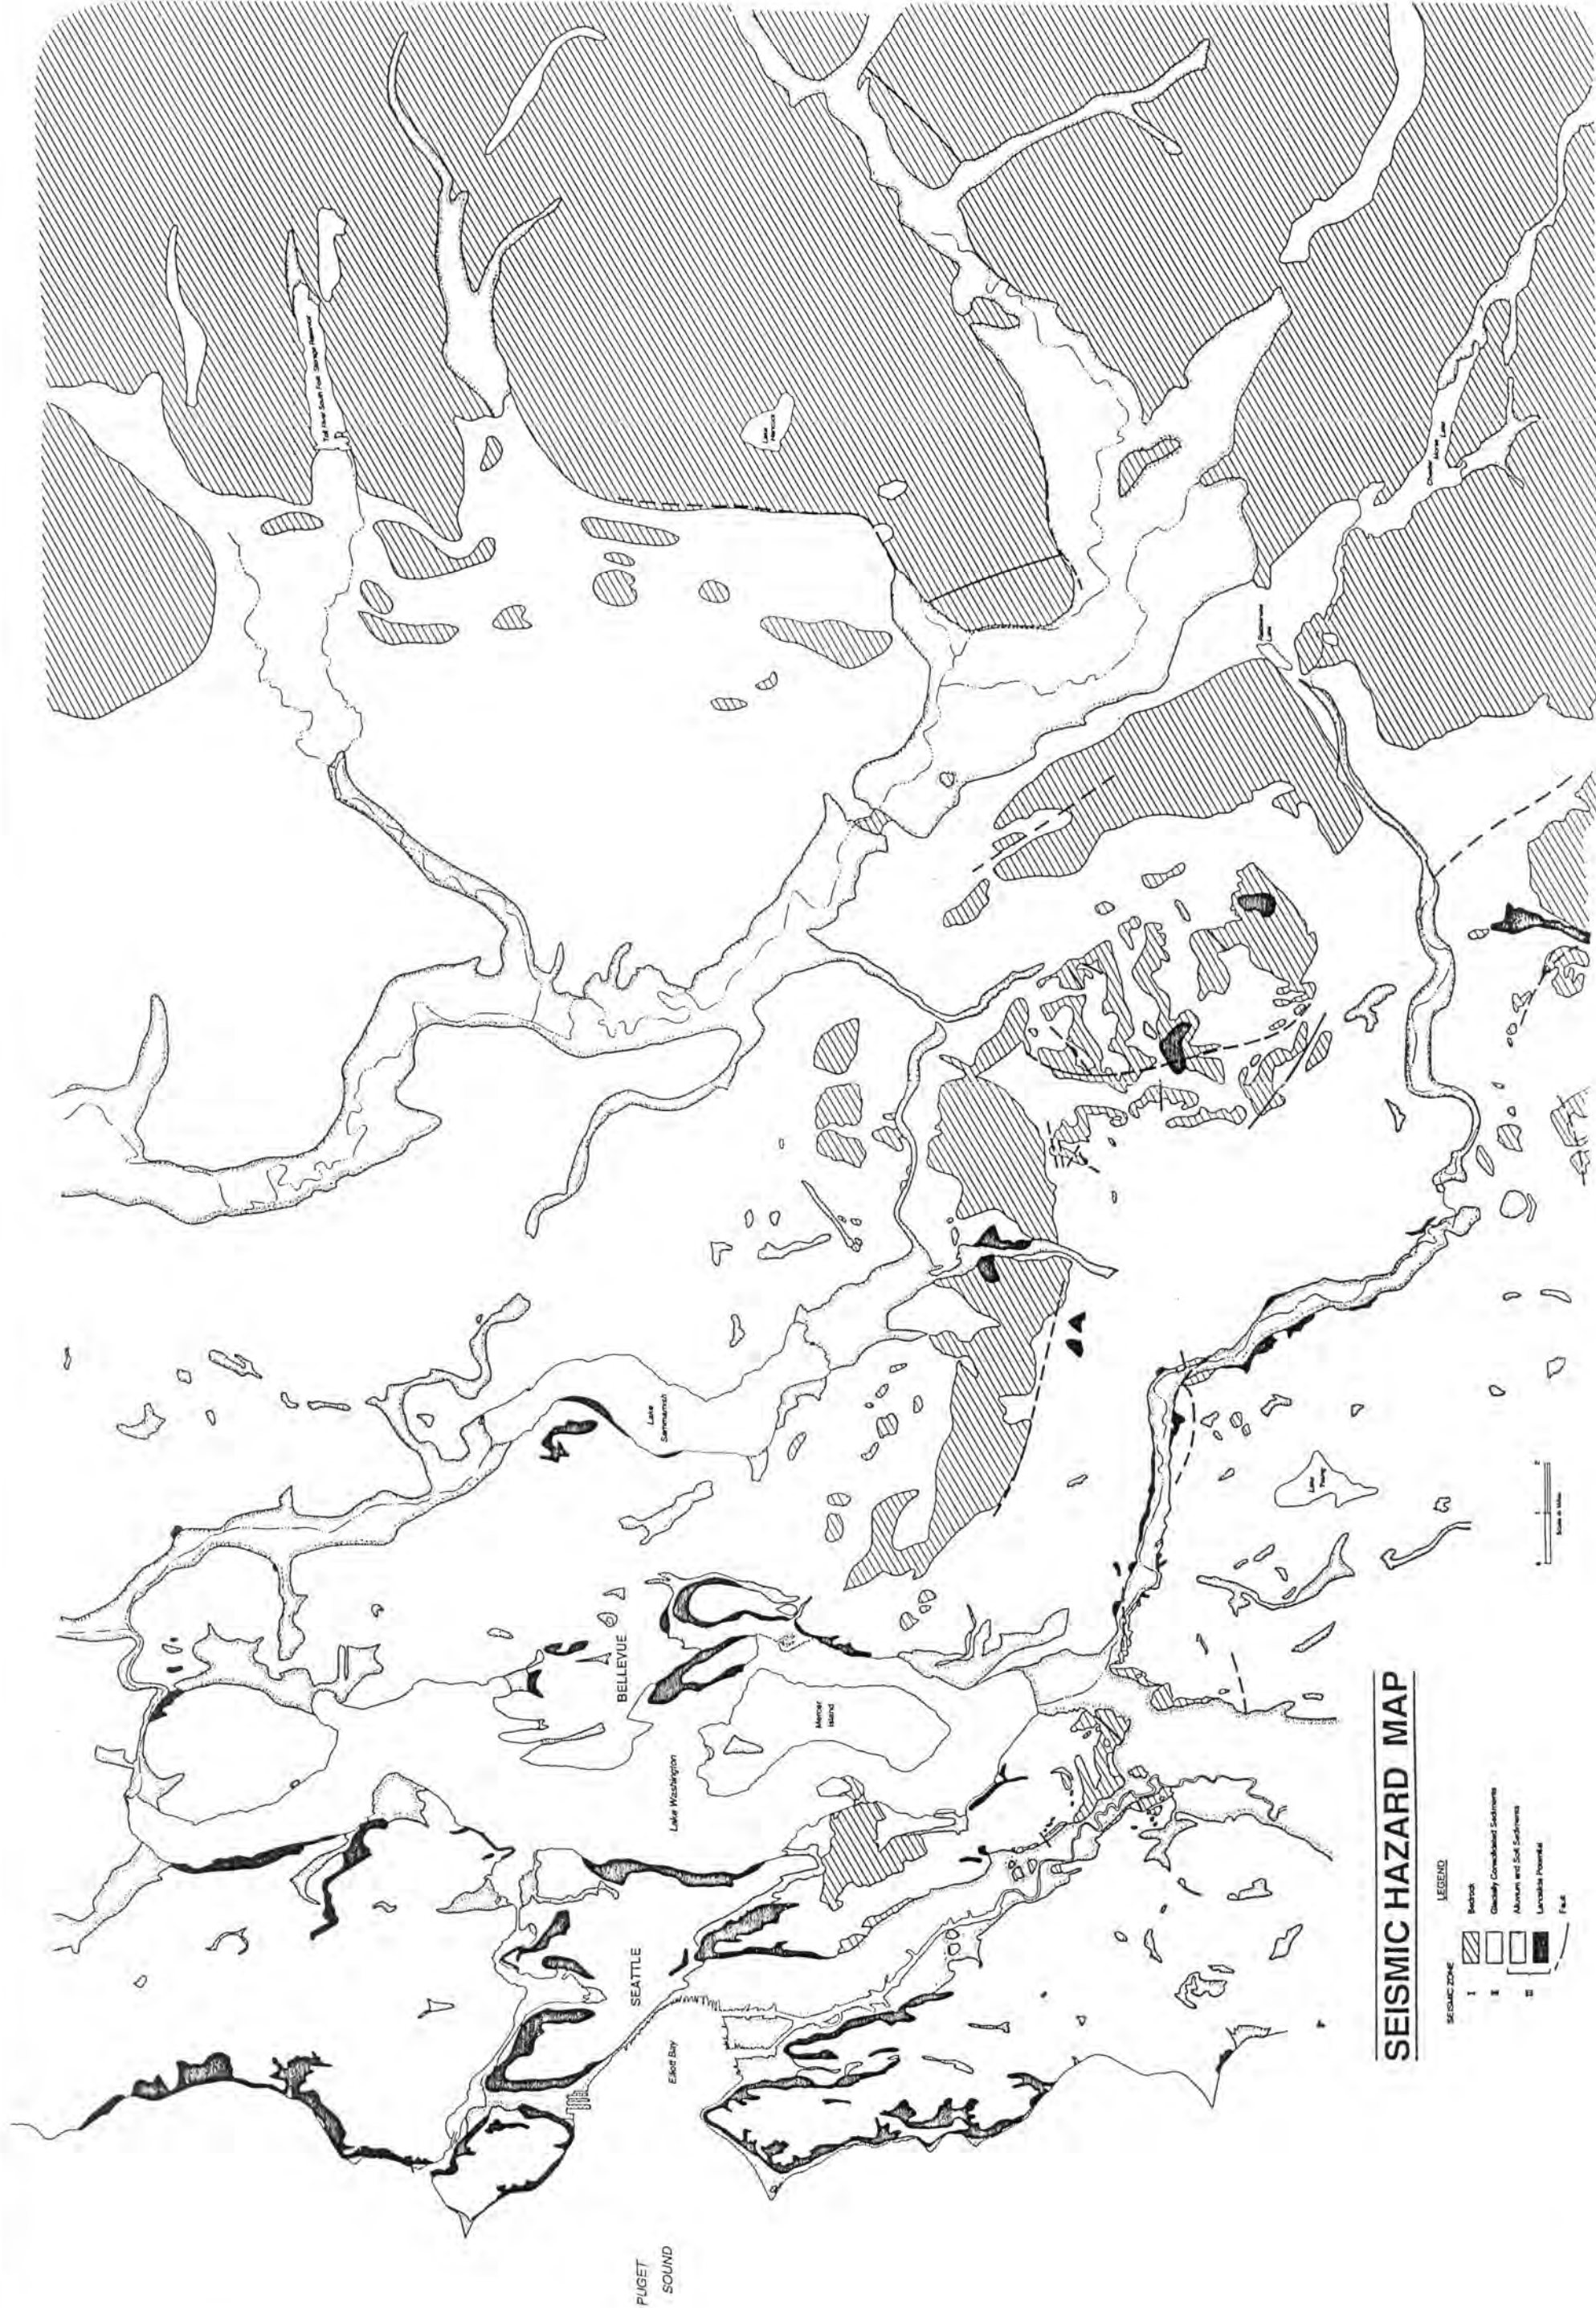
SEISMIC HAZARD MAP

The seismic hazard map presented in Figure 4.3-1 was originally prepared at a scale of 1 inch equals 1 mile to correspond to the SWD Facilities Map. A mylar copy of this full-scale map has been provided to the SWD for use as an overlay on their existing Facilities Map.

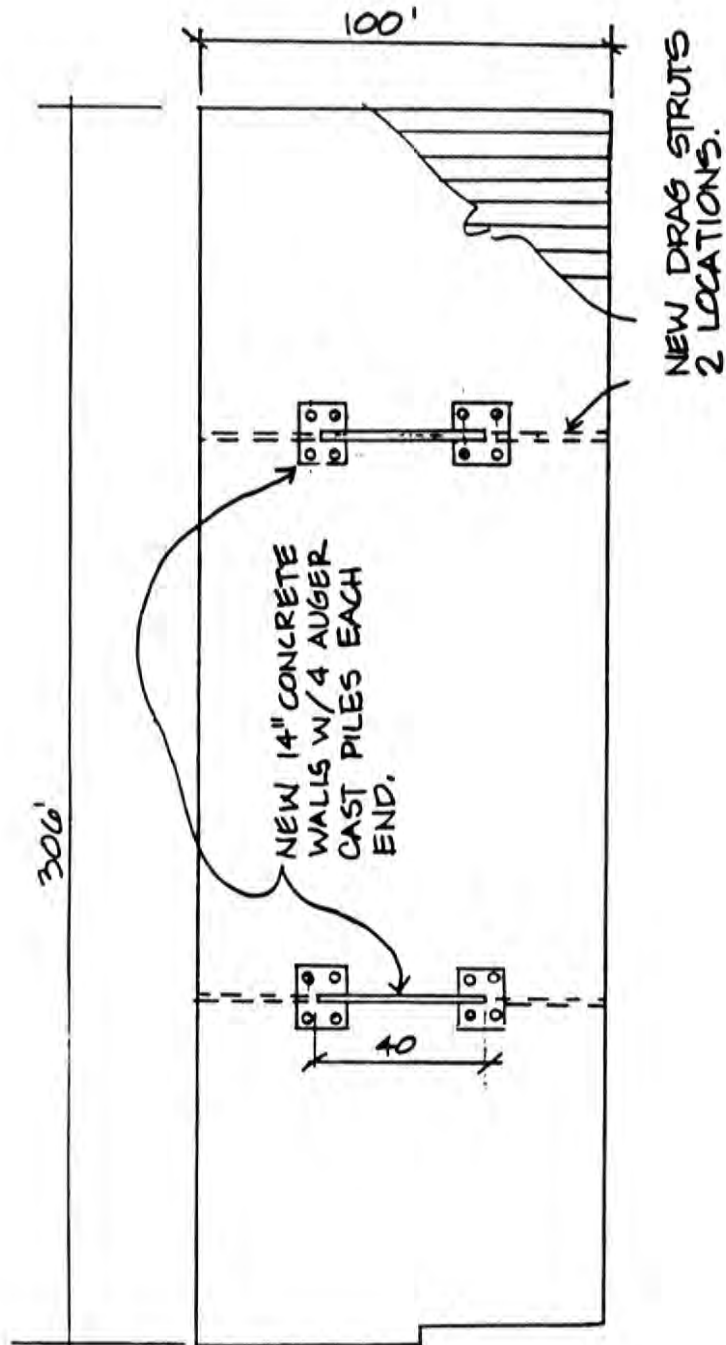
Figure 10.4-1

The Warehouse Building was constructed in 1972 and is located adjacent to the Administration Building on the south side. The building, shown in Figure 10.4-1, is rectangular with an East-West dimension of 100 ft. and a North-South dimension of 300 ft. The roof height is 22 ft. 6 in. The building foundation system is composed of a pile system supporting the columns and structural slab. The roof is constructed of prestressed single tees which span 100 ft. The flange portion of the tee forms the roof deck with no topping slab. The tees are supported on precast perimeter beams. The tilt up precast panels which form the exterior cladding of the building and function as shear walls tie into the perimeter beams and the structural slab.

- d) The interior contents of the building, with the above modifications described for the storage racks, should adequately resist the design earthquakes. The 150-lb. chlorine cylinders located near the outside south wall of the Warehouse Building should be more properly secured.

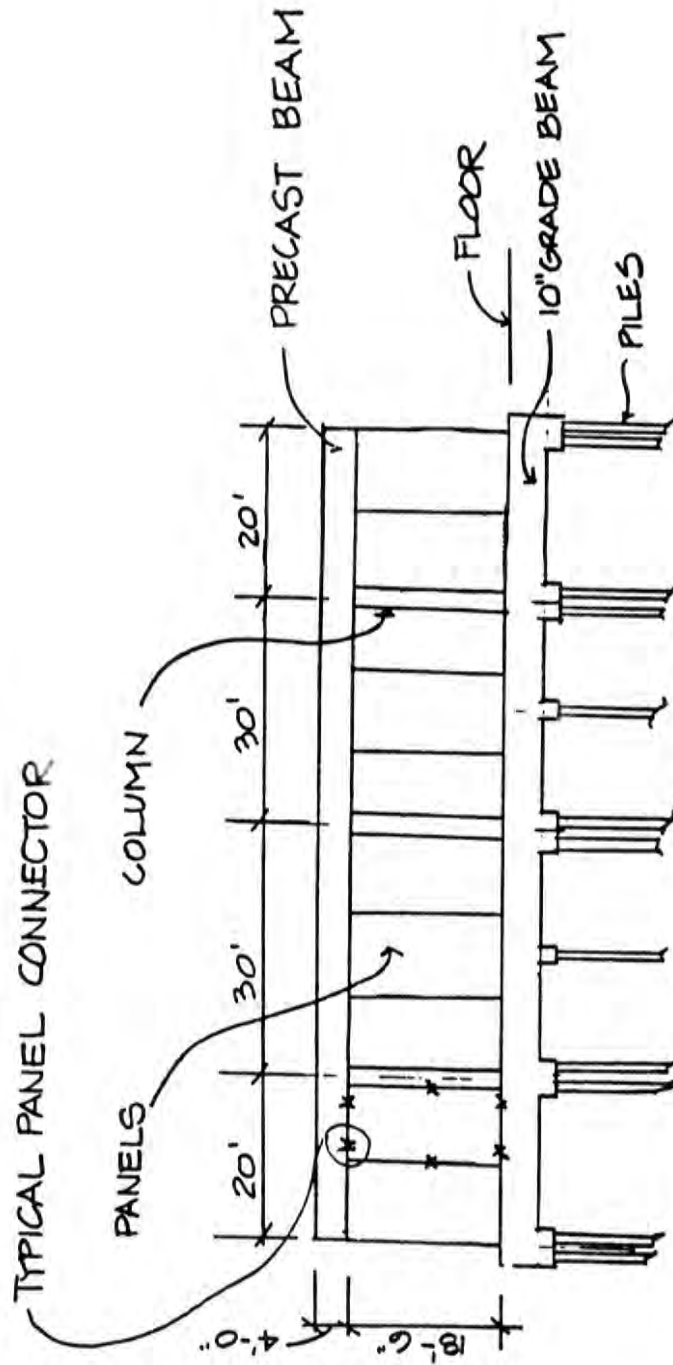
The precast wall panels, 18.5 ft. high by 10 ft. wide, are connected to the gravity structure at six locations, two connectors at the panel top to the spandrel beam, one each side to either adjacent panel or column, and two at the base of the panel to the structural slab. See Figure 10.4-2 for the south wall layout. The top and side connectors are composed of embedded threaded inserts, bolts and plates. The bottom connectors are bent reinforcing steel which is welded to a mating piece protruding from the slab. The panels appear to be designed to act independently, placing the bottom connector in both shear and tension. The weld is then stressed both longitudinally and transversely. The base connectors are the weakest link in that the failure mechanism is the weld being stressed in tension and in shear. This problem is magnified by the possible embrittlement of steel caused by welding on areas where the reinforcing steel is bent.

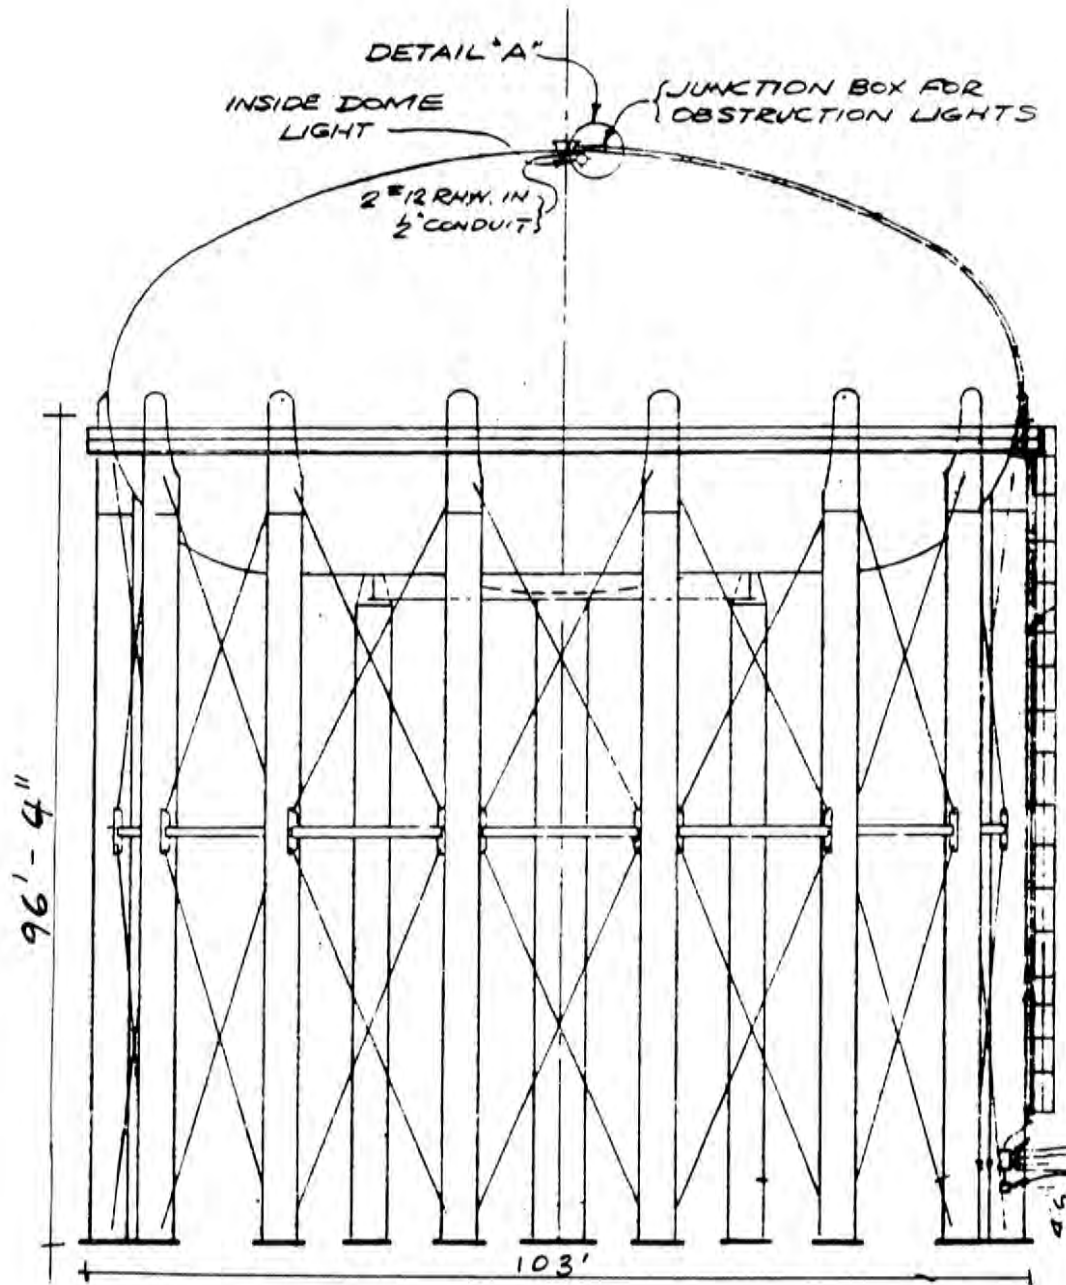
Figure 14.3-1

The Beverly Park elevated water storage tank, built in 1959, has a capacity of 2,000,000 gallons. The structure is shown in Figures 14.3-1 and 14.3-2. The elevated tank shell is supported at its equator by fourteen (14) braced columns with a diameter of 48 in. and a cross sectional area of approximately 70 sq. in. The braces have a cross section of 22 sq. in. There is a set of seven (7) unbraced interior columns and a central riser with a diameter of 72 in. and a cross section of approximately 56 sq. in. The columns are supported by spread footings with tie beams along the outside perimeter only.

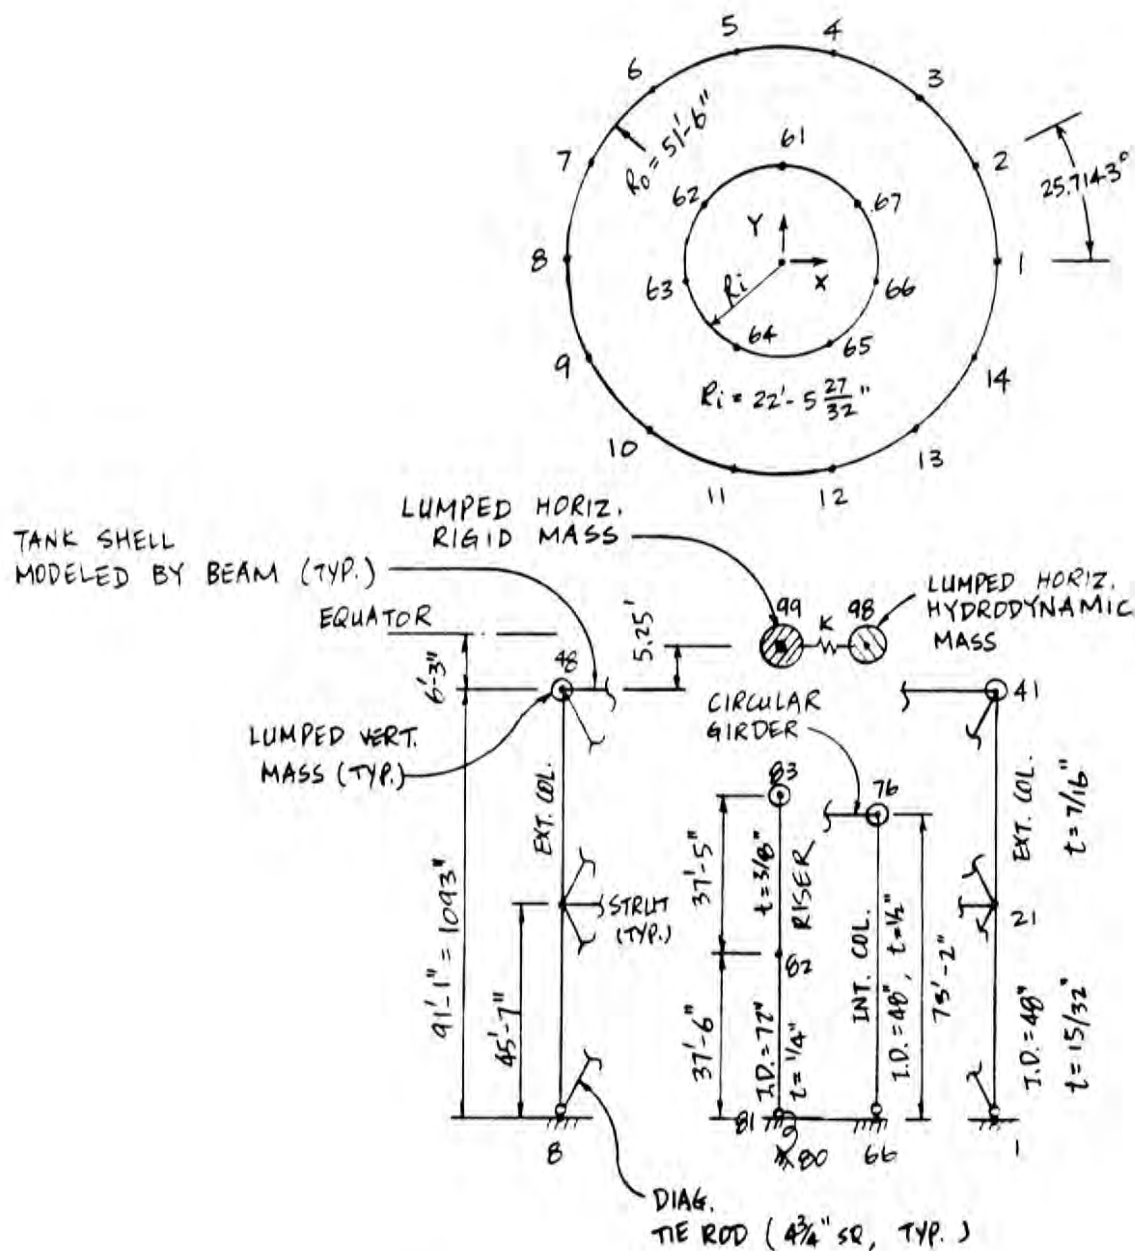
Figure 14.3-3

The computer program ANSYS was used for analysis of the tank. Using this program, a three dimensional model of the tank was developed as shown in Figure 14.3-3. The tank shell connection at the top of the columns was modeled by coupling the horizontal displacements at the top of the columns, and using an equivalent ring beam to restrain the rotations. This assumption is justified because at those connections forces are transferred primarily along the tangential surface of the tank. Along this tangential direction the tank wall is axially very rigid. It should also be noted that elevated tanks are "long period" structures and thus, any modeling assumptions which overestimate their rigidity are conservative because they result in higher spectral accelerations.

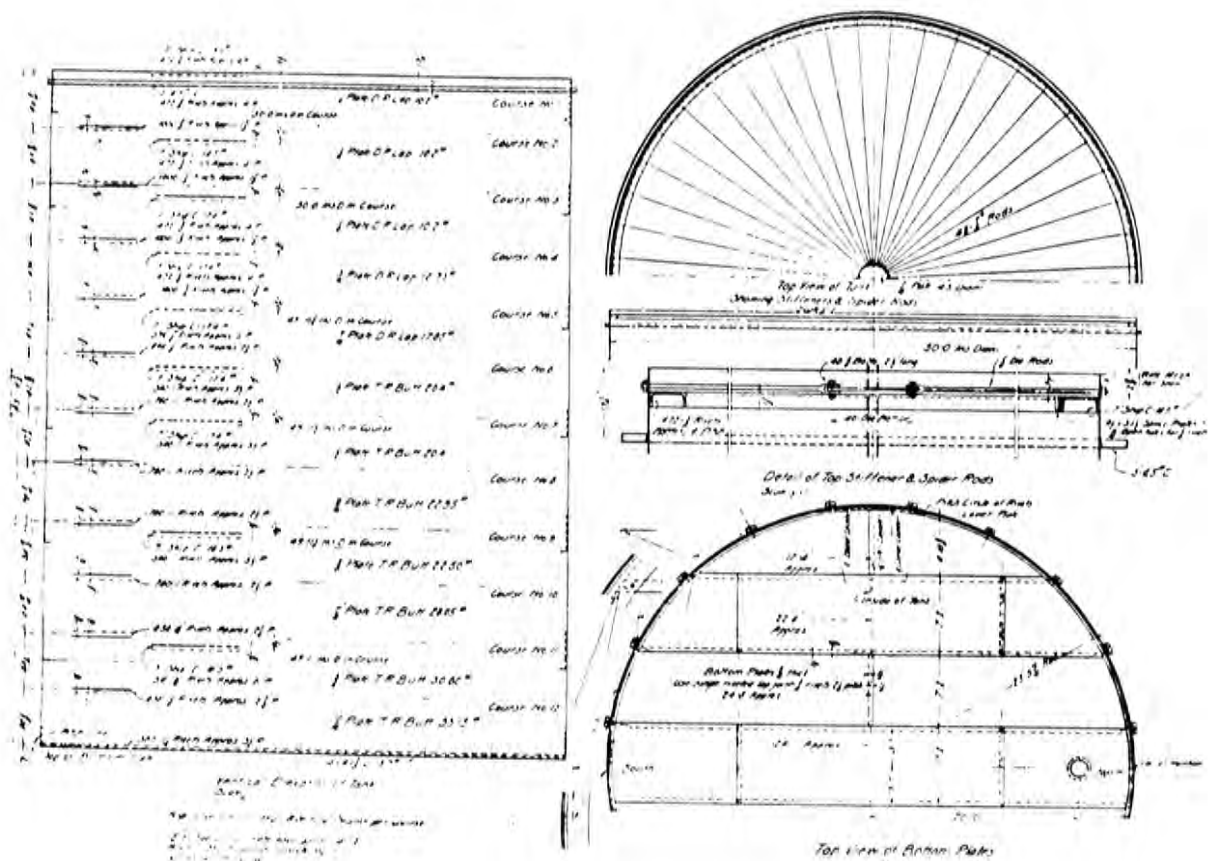
Figure 15.4-1

The Charlestown water storage standpipe, constructed in 1927, has a capacity of 883,000 gallons. The structure is shown in Figure 15.4-1. The structure has a diameter of approximately 50 ft. and a height of 62 ft. The cylindrical shell ranges in thickness from 1/4 in. to 13/16 in. The bottom plate is 5/16 in. thick. The tank is supported on a mat foundation, assumed to be 4 ft. thick and 56 ft. in diameter. Anchorage is provided by twenty 2 in. diameter bolts with 3 ft. 6 in. embedment.

Charlestown Water Storage Standpipe

The recommended upgrade solution for this standpipe is not simply to increase the number of anchor bolts. To do so would result in an increased overturning moment that the current foundation could not withstand. The upgrade solution is complicated by interference with the property line and neighboring structures. A possible fix would be to install twenty (20) new diagonal TS 6 x 6 x 3/8-in. braces which tie into a circumferential ring girder. These braces can take both tension and compression. They are equally distributed around the circumference of the tank and are anchored by a new ring foundation footing as shown in Figure 15.4-3.

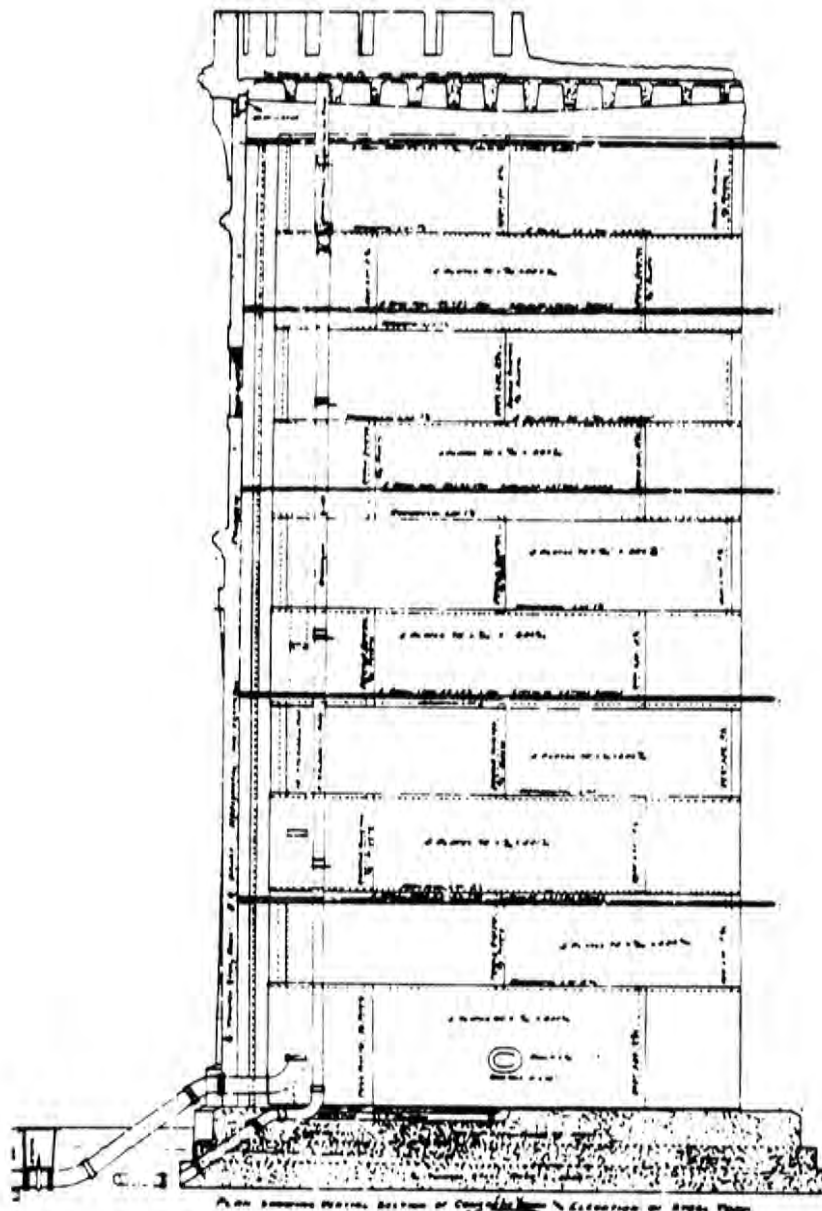
Figure 15.6-1

Queen Anne #1 Water Storage Standpipe

The recommended solution for this standpipe is not simply to increase the number of anchor bolts. To do so would result in an increased overturning moment that the current foundation could not withstand. The upgrade solution is complicated by interference with the property line and neighboring structures. It is recommended that nine (9) new TS 8 x 8 x $\frac{1}{2}$ -in. braces be installed which tie into a circumferential ring girder. These braces can take both tension and compression. They are equally distributed around the circumference of the tanks and are anchored by a new footing as shown in Figure 15.6-3.

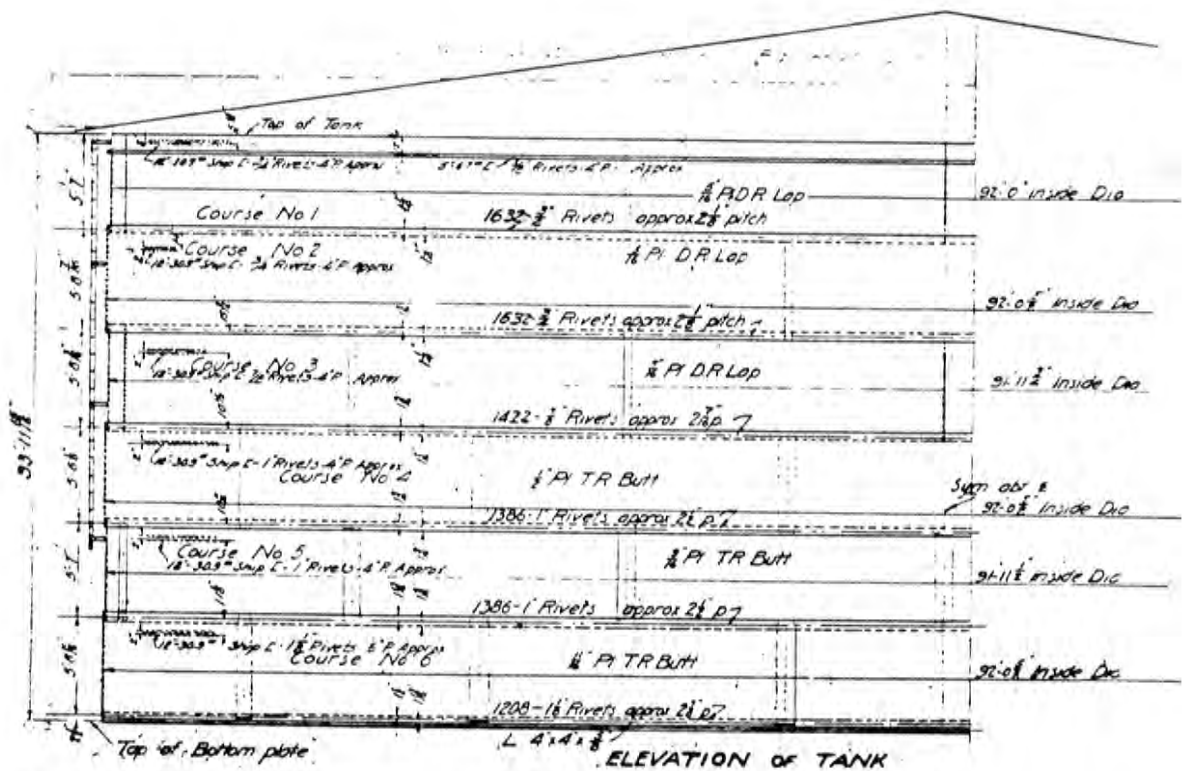
Figure 15.8-1

The SW Trenton North and South water storage standpipes have a capacity of 1,193,000 gallons. The structure, shown in Figure 15.8-1, has a diameter of approximately 92 ft. and a height of 36 ft. The cylindrical shell ranges in thickness from 5/16 in. to 11/16 in. The bottom plate is 5/16-in. thick. The tank is supported on a mat foundation, assumed to be 4-ft. thick and 97-ft. in diameter. No anchorage is provided.

SW Trenton North and South Water Storage Standpipes

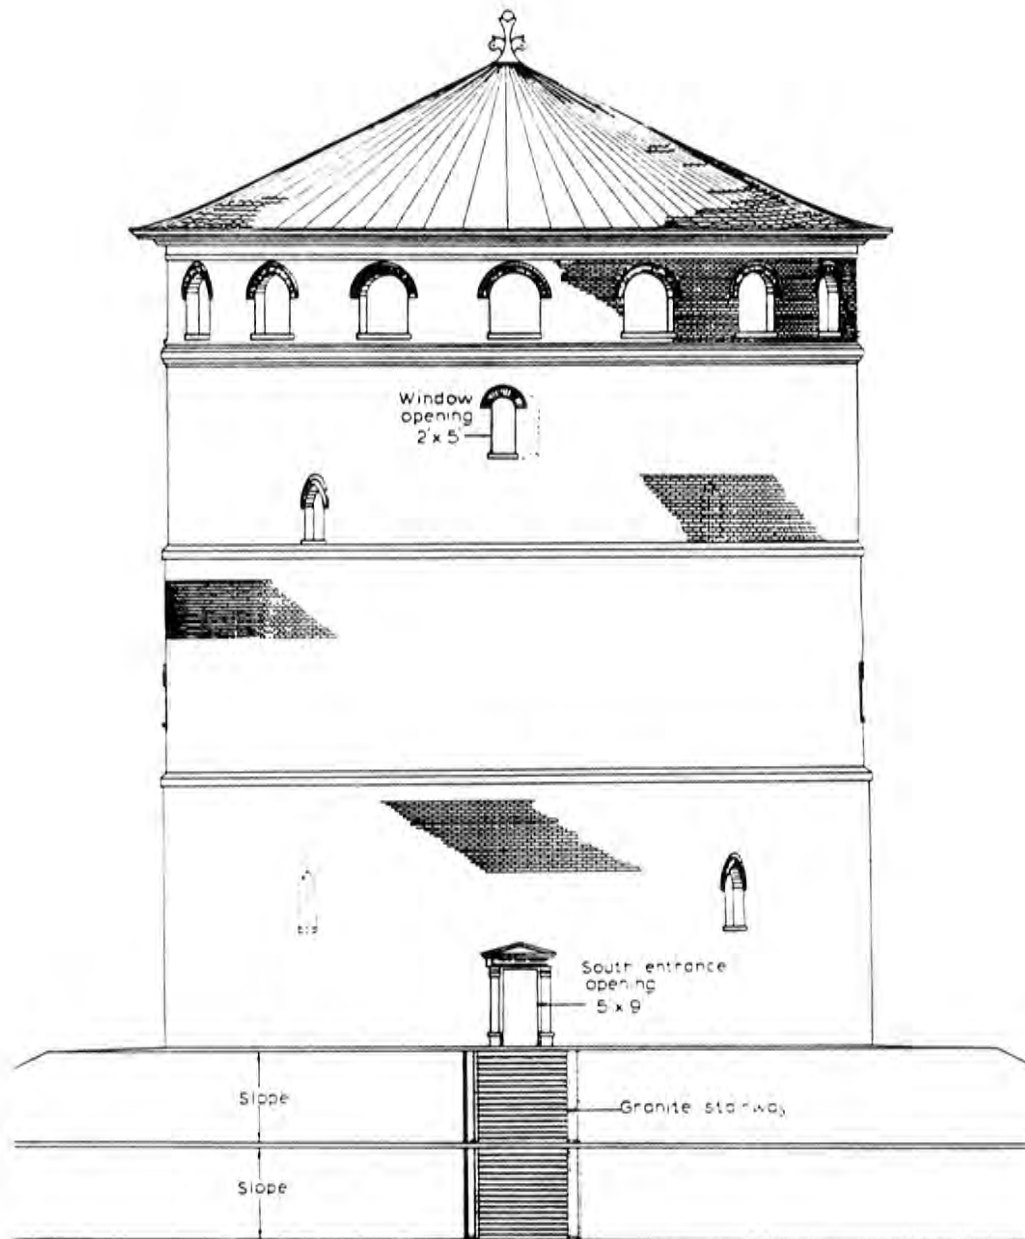
Figure 15.9-1

Volunteer Park Water Storage Standpipe

The recommended solution for this standpipe is not simply to increase the number of anchor bolts. To do so would result in an increased overturning moment that the current foundation could not withstand. The upgrade solution is complicated by interference with the property line and neighboring structures. A possible design fix would be to install twenty (20) new diagonal TS 6 x 6 x 3/8-in. braces which tie into a circumferential ring girder. These braces can take both tension and compression. They are equally distributed around the circumference of the tank and are anchored by a new ring foundation footing, similar to that shown in Figure 15.4-3.

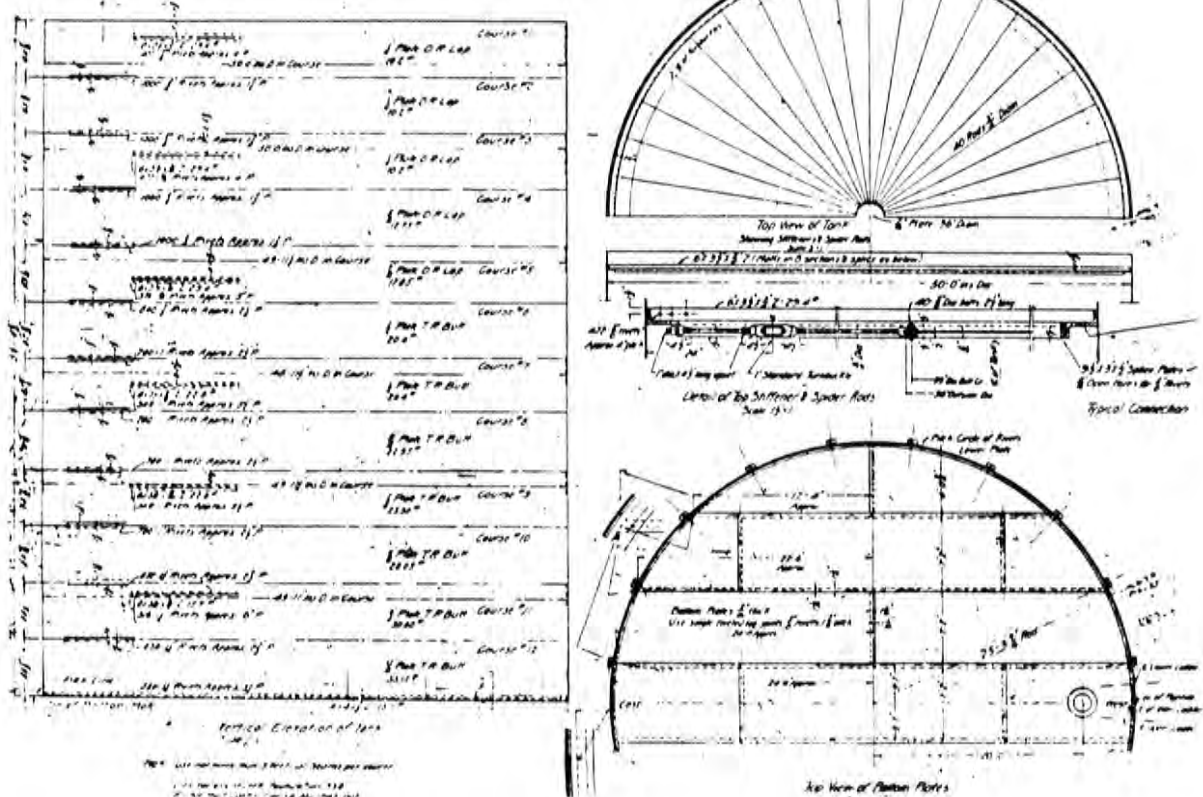
Figure 15.10-1

Woodland Park Water Storage Standpipe
